# Intel® Itanium™ Processor

## Specification Update

*July 2001*

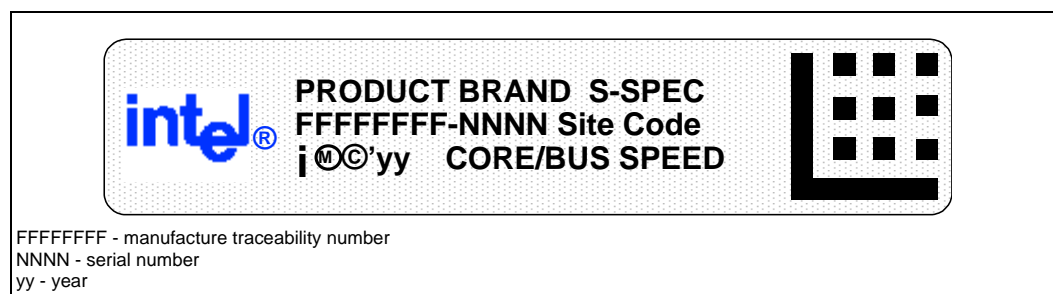
The cartridge mark for the product is a laser marked label attached to the end of the PAC418 cartridge opposite the power tab. The mark provides the following information:

- Product brand name
- Manufacture traceability (including manufacturing lot and unit identification)
- Manufacturing site
- Mask work and copyright protection for the processor and cache die
- Product identification (including processor core speed, cache size, bus speed)
- Intel company logo
- Two-dimensional product identification matrix for Intel internal use
